**Flood Control Project Maintenance
Levee Inspections**

Maintenance Issue Types Only, Levee Inspection Report By Mile - Spring 2017

Reclamation District No. 2091 Chase

Waterway	Bank	Unit Miles	Inspection Start/End	Inspector
Unit No. 01 San Joaquin River	Right	7.46	04/12/2017 04/12/2017	Richard Willoughby

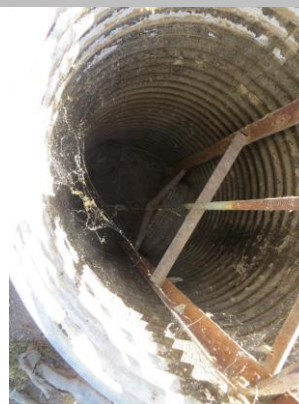
Photo 2 of 3 : UCIP_SP_2017_43207_38147.jpg

LM Start	0.08	Rating **	M	Issue No.	23
LM End	0.08	Issue Type +	Ma	Location *	WS
Category	Supplemental			GPS Latitude/Longitude	
				Start	End
Item	DWR UCIP LMA Responsibility			37.541970 °	37.541970 °
				-121.093980 °	-121.093980 °
DWR ID					
Comment Code					
Inspector Comment					
FS_ID:43207 DS_ID:23155 EP_NO: N/A Repair Type: Non-Urgent Crossing Status: Found UCIP Comments: Appears abandoned and if so should be done so properly. FIELD_STRUCT_DESC: *ABANDONED* 24-inch corrugated metal pipe through levee 7.2 feet below crown. Slide gate in 36-inch corrugated metal pipe riser on the waterward slope. Originally included in the 1961 O&M manual. As built drawings available, Drawing # 07-04-1555: 1555/17 & 1555/55, 906+85. FS Date: 1/29/2015 2:26:31 PM

Slide gate in 36-inch CMP riser on WS toe.

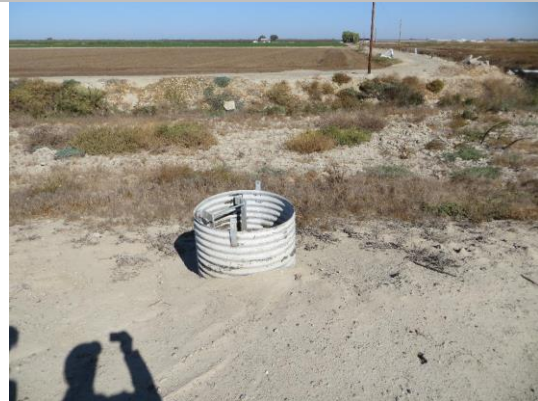
Photo 1 of 3 : UCIP_SP_2017_51387_38150.jpg

FS_ID:51387
DS_ID:23156
EP_NO: N/A
Repair Type: Urgent
Crossing Status: Found
UCIP Comments: 11/18/2016 Same as last inspection this is a non-functional crossing with no visible inlet on LS or outlet on WS. The only appurtenance found at this location is a CMP riser with a missing cover located on the WS. This crossing remains Urgent since the pipe on the WS may still be opened. According to Mike Alves, this crossing is abandoned and the City of Modesto is working with CVFPB to authorize proper abandonment/removal. The City is working at finding funds to pay for proper abandonment/removal of all the drainage structures through this levee. (O. Magana - DWR UCIP)01/29/2015 Pipe open on WS and slide gate has been removed. Appears abandoned and should be done so properly. (M. Alves - City of Modesto)
FIELD_STRUCT_DESC: *ABANDONED* 24-inch corrugated metal drainage pipe through levee, 9 feet below crown. Slide gate in corrugated metal pipe (CMP) riser located on the waterside (WS) slope.

36-inch CMP riser on WS slope.

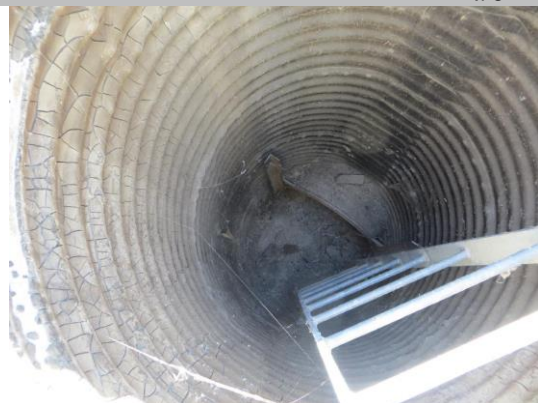
Photo 2 of 3 : UCIP_SP_2017_51387_38149.jpg

Slide gate missing from open end of pipe at WS slope.

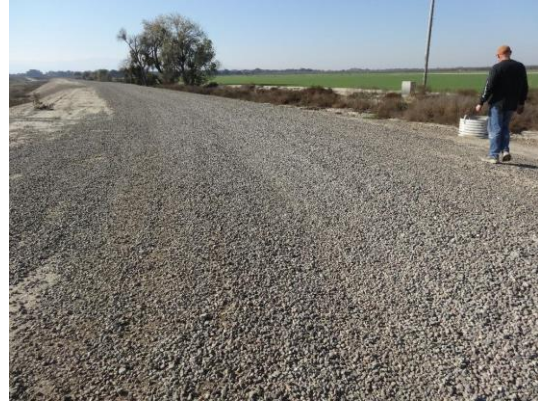
Photo 3 of 3 : UCIP_SP_2017_51387_76669.jpg

FS_ID:51387
DS_ID:23156
EP_NO: N/A
Repair Type: Urgent
Crossing Status: Found
UCIP Comments: 11/18/2016 Same as last inspection this is a non-functional crossing with no visible inlet on LS or outlet on WS. The only appurtenance found at this location is a CMP riser with a missing cover located on the WS. This crossing remains Urgent since the pipe on the WS may still be opened. According to Mike Alves, this crossing is abandoned and the City of Modesto is working with CVFPB to authorize proper abandonment/removal. The City is working at finding funds to pay for proper abandonment/removal of all the drainage structures through this levee. (O. Magana - DWR UCIP)01/29/2015 Pipe open on WS and slide gate has been removed. Appears abandoned and should be done so properly. (M. Alves - City of Modesto)
FIELD_STRUCT_DESC: *ABANDONED* 24-inch corrugated metal drainage pipe through levee, 9 feet below crown. Slide gate in corrugated metal pipe (CMP) riser located on the waterside (WS) slope. [Additional Reference(s): DWR Levee Log, 1992. USACE San Joaquin River O&M Manual Unit 6, September 1961, (HLM 0.07), Drawing No. 07-04-1555, sheet(s) 1555/17 and 1555/55, reference station 907+55].

Overview of levee crown at pipe crossing.

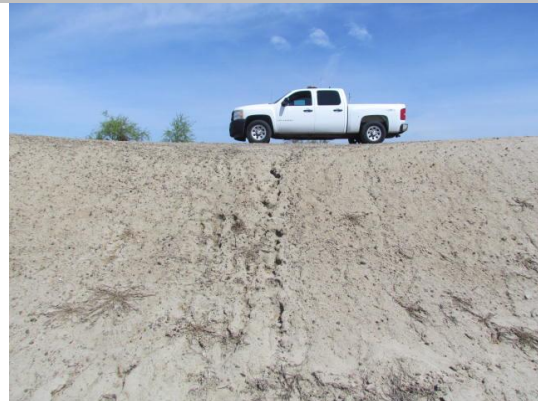
Photo 1 of 4 : SP_2017_RD2091_318_15_20170412_00008.jpg

Caving on landward shoulder possible collapsed pipe. Caving is 34 feet long over one inch depth.

Looking west at dip on landward levee shoulder.

E1 : Note and monitor erosion site.

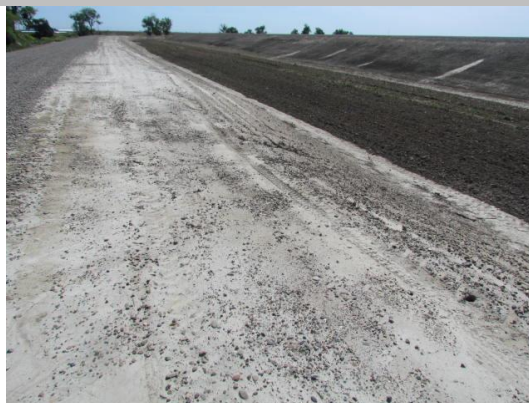
Photo 2 of 4 : SP_2017_RD2091_318_15_20170412_00009.jpg

LM Start	0.23	Rating **	U	Issue No.	15 (cont)	
LM End	0.23	Issue Type +	Ma	Location *	LS	
Category	Earthen Levee			GPS Latitude/Longitude		
				Start		End
Item	Erosion / Bank Caving			37.541550 °		37.541550 °
				-121.096742 °		-121.096742 °
DWR ID	DWR_RD2091_01_s_2016_15					
Comment Code						
E1 : Note and monitor erosion site.						
Inspector Comment						
Caving on landward shoulder possible collapsed pipe. Caving is 34 feet long over one inch depth.

Looking southeast at depression along landward shoulder.

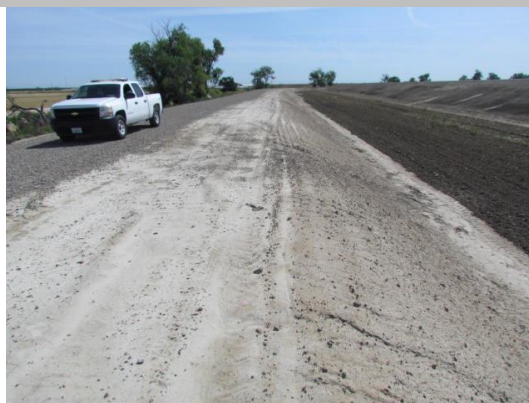
Photo 3 of 4 : SP_2017_RD2091_318_15_20170412_00010.jpg

Looking south at depression along landward shoulder.

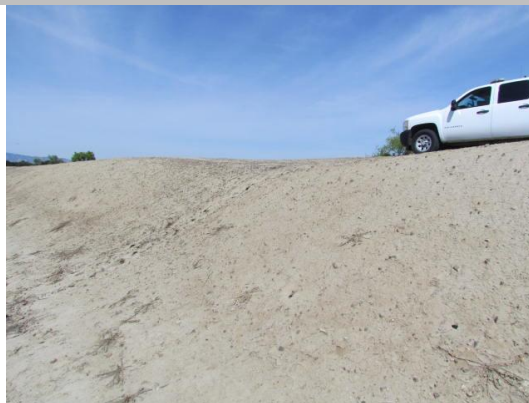
Photo 4 of 4 : SP_2017_RD2091_318_15_20170412_00011.jpg

Looking northwest at depression along landward shoulder.

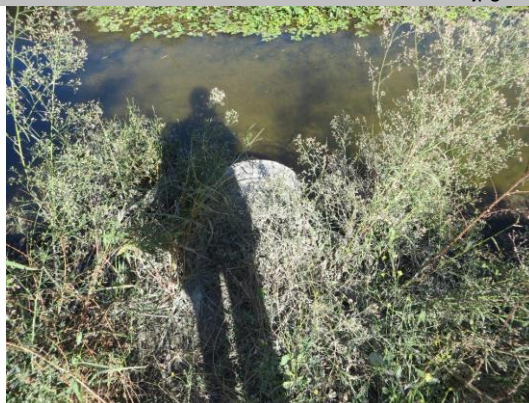
Photo 1 of 3 : UCIP_SP_2017_51388_38156.jpg

FS_ID:51388
DS_ID:23158
EP_NO: N/A
Repair Type: Urgent
Crossing Status: Found
UCIP Comments: 11/18/2016 Same as last inspection. This crossing remains Urgent due to the flap gate still missing from the WS toe.
According to Mike A. this crossing is an abandoned line and the City of Modesto is working with CVFPB to authorize proper abandonment/removal. The City is working at finding funds to pay for proper abandonment/removal of all the drainage structures through this levee. (O. Magana - DWR UCIP)01/29/2015 Flap gate has fallen off at WS toe. Appears abandoned and if so should be done so properly. (M. Alves - City of Modesto)
FIELD_STRUCT_DESC: *ABANDONED* 24-inch corrugated metal drainage pipe through levee, 10 feet below crown. Flap gate located on the waterside (WS) end. Drain opening is located approximately 15 feet off the landside (LS) toe. [Additional Reference(s): DWR Levee Log, 1992. USACE San Joaquin River O&M Manual Unit 6, September 1961, (HLM 0.23), Drawing No. 07-04-1555, sheet(s) 1555/17 and 1555/55, reference station 915+00].

Pipe visible in canal on WS toe.

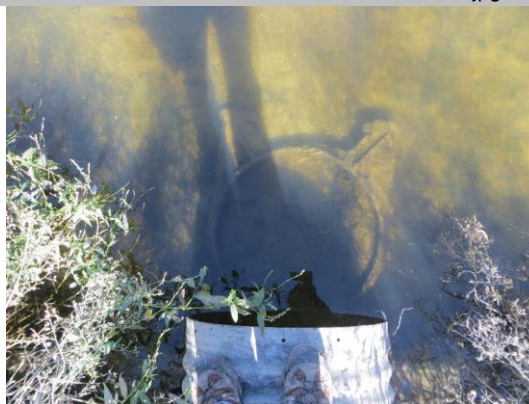
Photo 2 of 3 : UCIP_SP_2017_51388_38155.jpg

Flapgate has fallen off at WS toe.

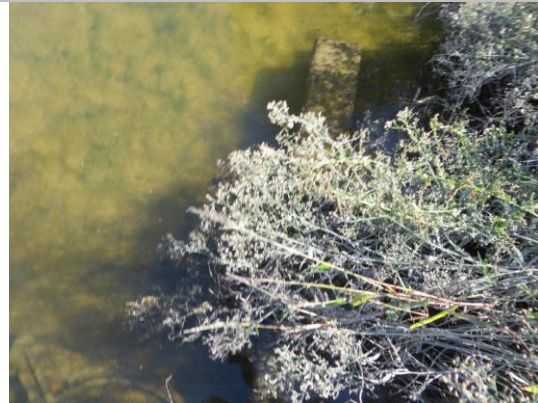
Photo 3 of 3 : UCIP_SP_2017_51388_38154.jpg

Comment Code						
Inspector Comment						
FS_ID:51388 DS_ID:23158 EP_NO: N/A Repair Type: Urgent Crossing Status: Found UCIP Comments: 11/18/2016 Same as last inspection. This crossing remains Urgent due to the flap gate still missing from the WS toe. According to Mike A. this crossing is an abandoned line and the City of Modesto is working with CVFPB to authorize proper abandonment/removal. The City is working at finding funds to pay for proper abandonment/removal of all the drainage structures through this levee. (O. Magana - DWR UCIP)01/29/2015 Flap gate has fallen off at WS toe. Appears abandoned and if so should be done so properly. (M. Alves - City of Modesto) FIELD_STRUCT_DESC: *ABANDONED* 24-inch corrugated metal drainage pipe through levee, 10 feet below crown. Flap gate located on the waterside (WS) end. Drain opening is located approximately 15 feet off the landside (LS) toe. [Additional Reference(s): DWR Levee Log, 1992. USACE San Joaquin River O&M Manual Unit 6, September 1961, (HLM 0.23), Drawing No. 07-04-1555, sheet(s) 1555/17 and 1555/55, reference station 915+00]. FS Date: 11/18/2016

Concrete headwall under pipe at WS toe.

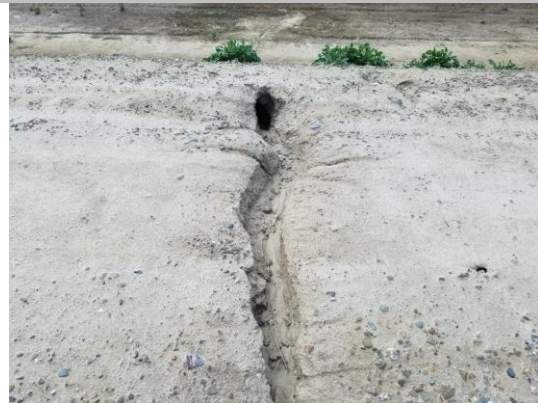
Photo 1 of 3 : SP_2017_RD2091_318_16_20170412_00044.jpg

LM Start	0.25	Rating **	M	Issue No.	16
LM End	0.28	Issue Type +	Ma	Location *	LS
Category	Earthen Levee			GPS Latitude/Longitude	
				Start	End
Item	Erosion / Bank Caving			37.541492 °	37.541408 °
				-121.097052 °	-121.097453 °
DWR ID	DWR_RD2091_01_s_2016_16				
Comment Code					
E1 : Note and monitor erosion site.					
Inspector Comment					
Several sites of rill erosion and possible rodent holes along landward shoulder and slope.

Looking east at rill erosion above rodent hole on landward slope. (Spring 2017)

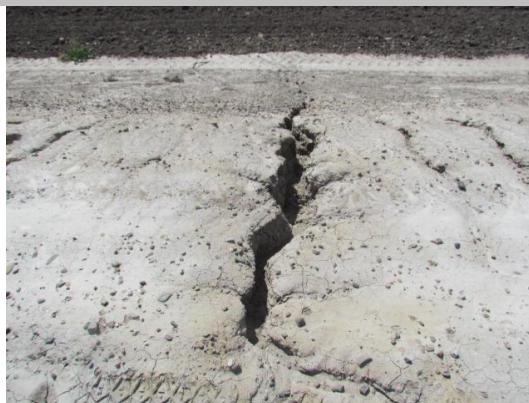
Photo 2 of 3 : SP_2017_RD2091_318_16_20170412_00012.jpg

LM Start	0.25	Rating **	M	Issue No.	16 (cont)	
LM End	0.28	Issue Type +	Ma	Location *	LS	
Category	Earthen Levee			GPS Latitude/Longitude		
				Start		End
Item	Erosion / Bank Caving			37.541492 °		37.541408 °
				-121.097052 °		-121.097453 °
DWR ID	DWR_RD2091_01_s_2016_16					
Comment Code						
E1 : Note and monitor erosion site.						
Inspector Comment						
Several sites of rill erosion and possible rodent holes along landward shoulder and slope.

Looking east at rill erosion on landward slope.

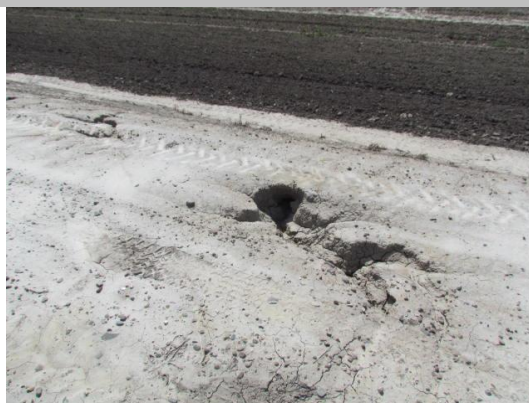
Photo 3 of 3 : SP_2017_RD2091_318_16_20170412_00013.jpg

Looking east at rill erosion and possible rodent hole on landward slope.

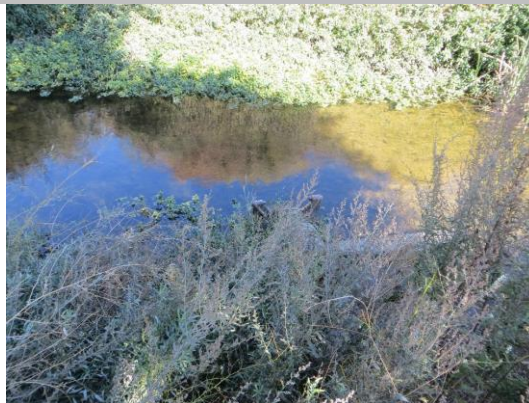
Photo 1 of 3 : UCIP_SP_2017_51639_38158.jpg

FS_ID:51639
DS_ID:23161
EP_NO: N/A
Repair Type: Non-Urgent
Crossing Status: Found
UCIP Comments: 11/18/2016 Crossing has been downgraded from Urgent to Non-Urgent since the flap gate appears to fully close. According to Mike Alvez, this crossing is abandoned and the City of Modesto is working with CVFPB to authorize proper abandonment/removal. The City is working at finding funds to pay for proper abandonment/removal of all the drainage structures through this levee. (O. Magana - DWR UCIP)01/29/2015 Appears abandoned and if so should be done so properly. (M. Alvez - City of Modesto)
FIELD_STRUCT_DESC: *ABANDONED* 24-inch corrugated metal drainage pipe through levee, 12 feet below crown. Flap gate and concrete headwall are located on the waterside (WS) end. [Additional Reference(s): DWR Levee Log, 1992. USACE San Joaquin River O&M Manual Unit 6, September 1961, (HLM 0.64)].
FS Date: 11/18/2016

24-inch CMP on concrete headwall with flapgate on WS toe.

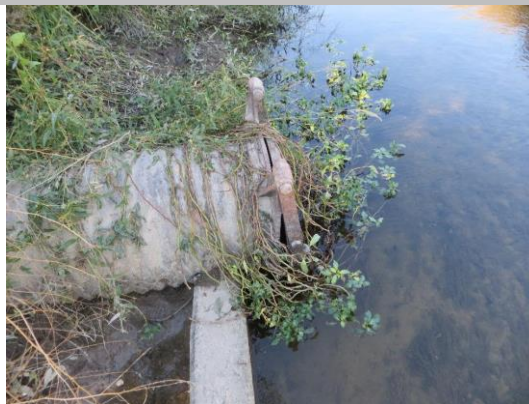
Photo 2 of 3 : UCIP_SP_2017_51639_38157.jpg

24-inch CMP on concrete headwall with flapgate on WS toe.

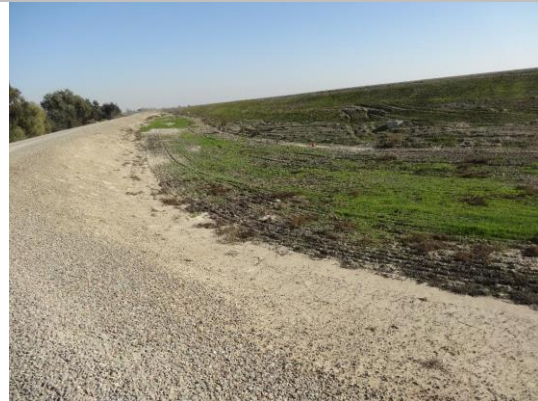
Photo 3 of 3 : UCIP_SP_2017_51639_76677.jpg

Comment Code					
Inspector Comment					
FS_ID:51639 DS_ID:23161 EP_NO: N/A Repair Type: Non-Urgent Crossing Status: Found UCIP Comments: 11/18/2016 Crossing has been downgraded from Urgent to Non-Urgent since the flap gate appears to fully close. According to Mike Alvez, this crossing is abandoned and the City of Modesto is working with CVFPB to authorize proper abandonment/removal. The City is working at finding funds to pay for proper abandonment/removal of all the drainage structures through this levee. (O. Magana - DWR UCIP)01/29/2015 Appears abandoned and if so should be done so properly. (M. Alvez - City of Modesto) FIELD_STRUCT_DESC: *ABANDONED* 24-inch corrugated metal drainage pipe through levee, 12 feet below crown. Flap gate and concrete headwall are located on the waterside (WS) end. [Additional Reference(s): DWR Levee Log, 1992. USACE San Joaquin River O&M Manual Unit 6, September 1961, (HLM 0.64)]. FS Date: 11/18/2016

View of LS.

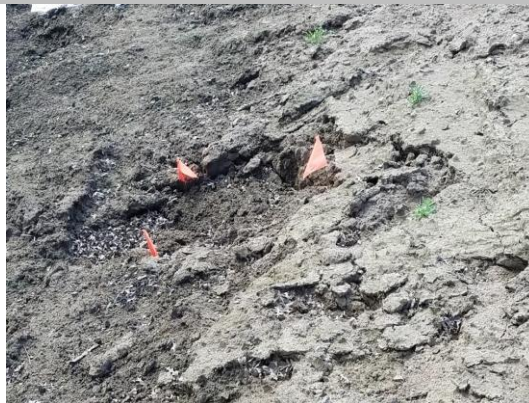
Photo 1 of 1 : SP_2017_RD2091_318_21_20170412_00045.jpg

LM Start	3.91	Rating **	M	Issue No.	21
LM End	3.91	Issue Type +	Ma	Location *	LS
Category	Earthen Levee			GPS Latitude/Longitude	
				Start	End
Item	Erosion / Bank Caving			37.506815 °	37.506815 °
				-121.082780 °	-121.082780 °
DWR ID	DWR_RD2091_01_s_2017_21				
Comment Code					
E2 : Schedule repair of erosion site prior to the next inspection.					
Inspector Comment					
Sinkhole at landward side toe

Looking south at possible sinkhole on landward toe.

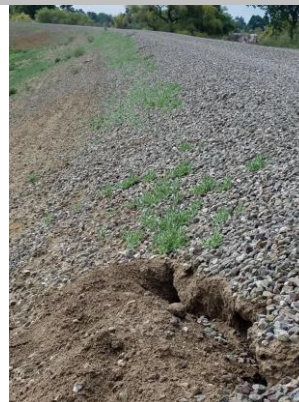
Photo 1 of 1 : SP_2017_RD2091_318_22_20170412_00046.jpg

LM Start	4.25	Rating **	M	Issue No.	22
LM End	4.25	Issue Type +	Ma	Location *	LS
Category	Earthen Levee			GPS Latitude/Longitude	
				Start	End
Item	Animal Control			37.501907 °	37.501907 °
				-121.082123 °	-121.082123 °
DWR ID	DWR_RD2091_01_s_2017_22				
Comment Code					
A3 : No rodents visible, but rodent burrows visible; need to backfill and compact or grout burrows.					
Inspector Comment

Looking south at rodent activity on landward shoulder and slope.

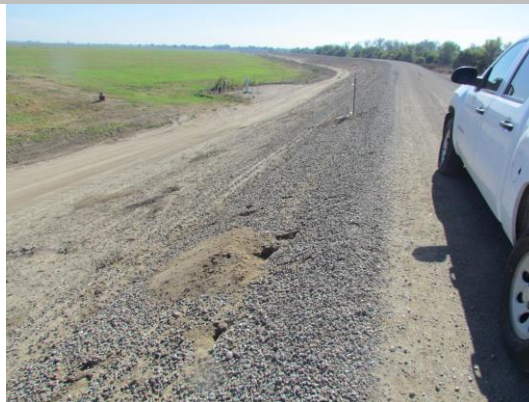
Photo 1 of 3 : SP_2017_RD2091_318_10_20170412_00001.jpg

LM Start	4.85	Rating **	U	Issue No.	10
LM End	4.85	Issue Type +	Ma	Location *	LS
Category	Earthen Levee			GPS Latitude/Longitude	
				Start	End
Item	Animal Control			37.494115 °	37.494115 °
				-121.078100 °	-121.078100 °
DWR ID	DWR_RD2091_01_f_2016_10				
Comment Code					
A3 : No rodents visible, but rodent burrows visible; need to backfill and compact or grout burrows.					
Inspector Comment					
Several large rodent holes on landward slope.

Looking south at several rodent holes on landward slope.

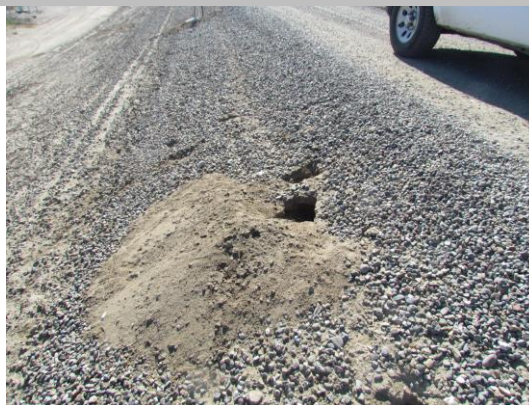
Photo 2 of 3 : SP_2017_RD2091_318_10_20170412_00002.jpg

LM Start	4.85	Rating **	U	Issue No.	10 (cont)
LM End	4.85	Issue Type +	Ma	Location *	LS
Category	Earthen Levee			GPS Latitude/Longitude	
				Start	End
Item	Animal Control			37.494115 °	37.494115 °
				-121.078100 °	-121.078100 °
DWR ID	DWR_RD2091_01_f_2016_10				
Comment Code					
A3 : No rodents visible, but rodent burrows visible; need to backfill and compact or grout burrows.					
Inspector Comment					
Several large rodent holes on landward slope.

Looking south at close-up view of rodent holes on landward slope.

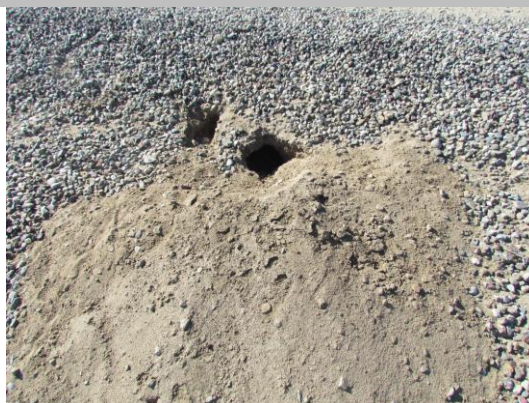
Photo 3 of 3 : SP_2017_RD2091_318_10_20170412_00003.jpg

Looking west at close-up view of rodent holes on landward slope.

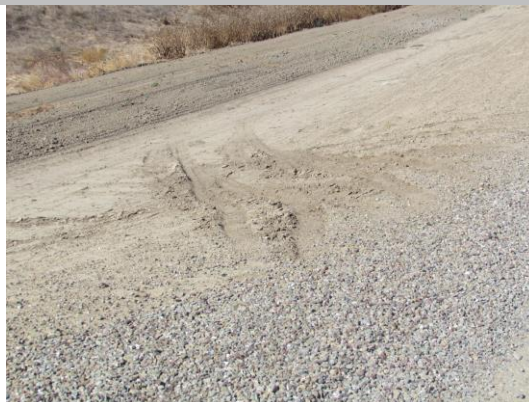
Photo 1 of 2 : SP_2017_RD2091_318_13_20170412_00006.jpg

LM Start	5.20	Rating **	M	Issue No.	13
LM End	5.20	Issue Type +	Ma	Location *	LS
Category	Earthen Levee			GPS Latitude/Longitude	
				Start	End
Item	Slope Stability			37.490756 °	37.490756 °
				-121.073410 °	-121.073410 °
DWR ID	DWR_RD2091_01_f_2016_13				
Comment Code					
S3 : Repair the levee slope damaged by vehicle traffic and prevent access where possible.					
Inspector Comment					
Vehicle traffic damaging slope on waterward and landward slope.

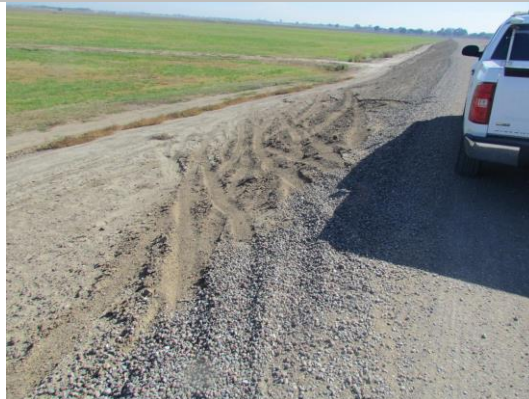
Photo 2 of 2 : SP_2017_RD2091_318_13_20170412_00007.jpg

LM Start	5.20	Rating **	M	Issue No.	13 (cont)	
LM End	5.20	Issue Type +	Ma	Location *	LS	
Category	Earthen Levee			GPS Latitude/Longitude		
				Start		End
Item	Slope Stability			37.490756 °		37.490756 °
				-121.073410 °		-121.073410 °
DWR ID	DWR_RD2091_01_f_2016_13					
Comment Code						
S3 : Repair the levee slope damaged by vehicle traffic and prevent access where possible.						
Inspector Comment						
Vehicle traffic damaging slope on waterward and landward slope.

Looking at damage on waterward slope.

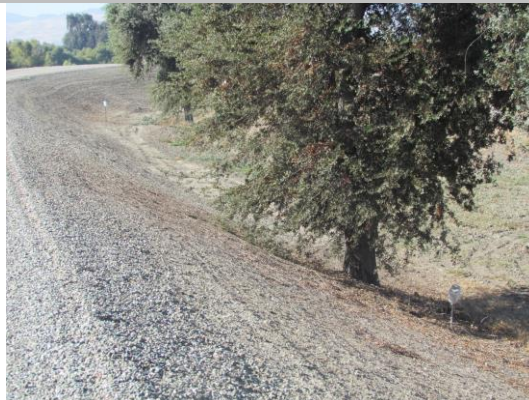
Photo 1 of 2 : SP_2017_RD2091_318_12_20170412_00004.jpg

LM Start	5.92	Rating **	M	Issue No.	12
LM End	5.92	Issue Type +	Ma	Location *	LS
Category	Earthen Levee			GPS Latitude/Longitude	
				Start	End
Item	Trim / Thin Trees			37.485998 °	37.485998 °
				-121.063323 °	-121.063323 °
DWR ID	DWR_RD2091_01_f_2015_12				
Comment Code					
T1 : Trim trees to at least five feet above ground level.					
Inspector Comment

Looking north at untrimmed tree at landward toe.

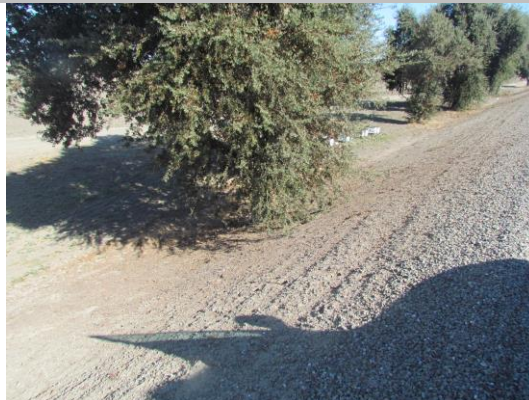
Photo 2 of 2 : SP_2017_RD2091_318_12_20170412_00005.jpg

Look southeast at untrimmed tree at landward toe.

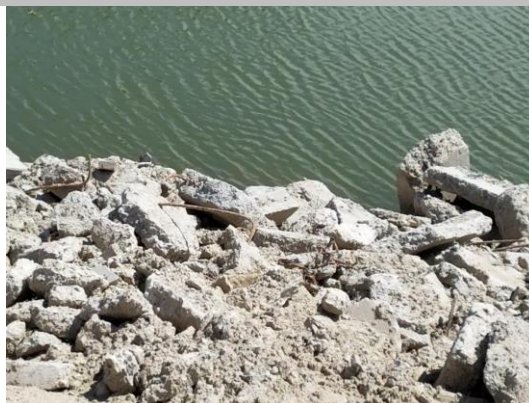
Photo 1 of 2 : SP_2017_RD2091_318_8_20170412_00047.jpg

LM Start	7.42	Rating **	U	Issue No.	8
LM End	7.45	Issue Type +	Ma	Location *	LS
Category	Earthen Levee			GPS Latitude/Longitude	
				Start	End
Item	Erosion / Bank Caving			37.479308 °	37.478998 °
				-121.044708 °	-121.044660 °
DWR ID	DWR_RD2091_01_s_2017_8				
Comment Code					
E2 : Schedule repair of erosion site prior to the next inspection.					
Inspector Comment					
Repaired area with concrete containing rebar. Need to remove rebar.

Looking east at concrete rubble with rebar at landward toe next to canal.

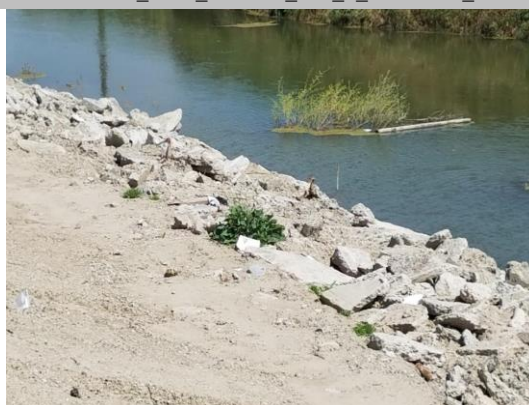
Photo 2 of 2 : SP_2017_RD2091_318_8_20170412_00048.jpg

Looking northeast at concrete rubble with rebar at landward toe next to canal.

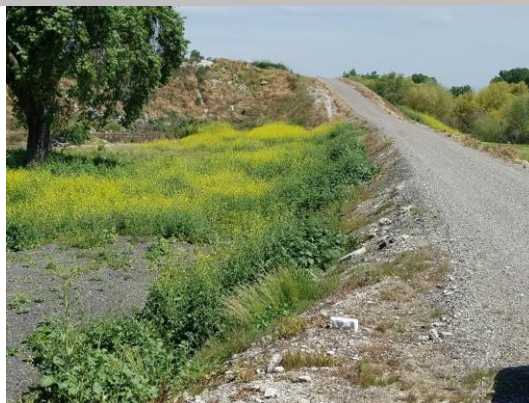
Photo 1 of 1 : SP_2017_RD2091_319_2_20170412_00006.jpg

Looking east at typical view of landward slope.

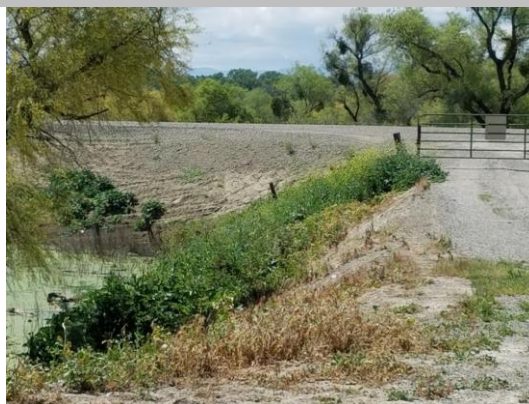
Photo 1 of 1 : SP_2017_RD2091_319_3_20170412_00005.jpg

LM Start	0.02	Rating **	M	Issue No.	3	
LM End	0.05	Issue Type +	Ma	Location *	WS	
Category	Earthen Levee			GPS Latitude/Longitude		
				Start		End
Item	Vegetation			37.482435 °		37.482727 °
				-121.051233 °		-121.050915 °
DWR ID	DWR_RD2091_02_s_2017_3					
Comment Code						
V1 : Control annual grass and weeds on the levee slopes and easements.						
Inspector Comment

Looking west at typical view of waterward slope.
